BRUSH WELLMAN, INC.
BERYLLIUM/MINING DIVISION

Topaz Mine

M/023/003

1995 ANNUAL REPORT
of Mining Operations

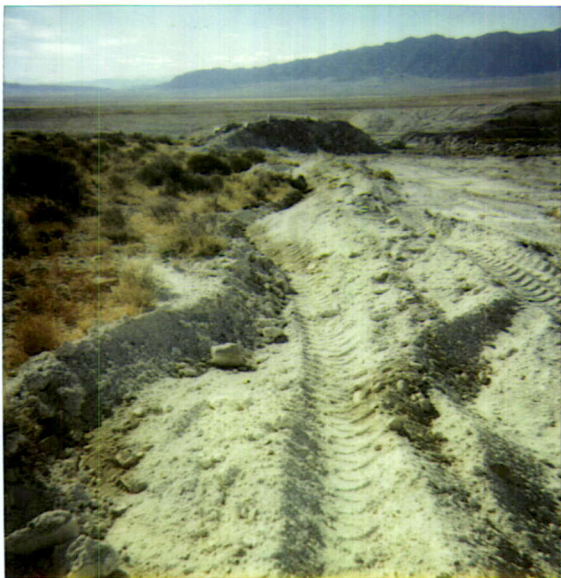
1.

- Photo 1** Picture of ditch diverging water to a holding pond from noneffected area and effected area to prevent erosion on east Sigma Emma road way, looking southwesterly.

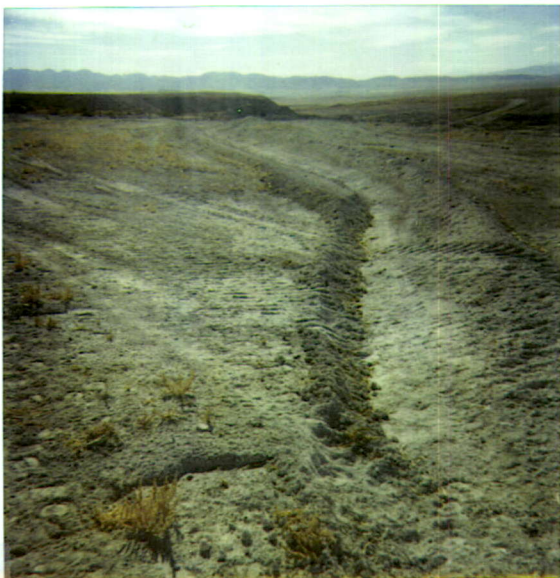
2.

- Photo 2** Picture of ditch diverging water to a holding pond in center of effected area to prevent erosion, looking southwesterly on east Sigma Emma road way.

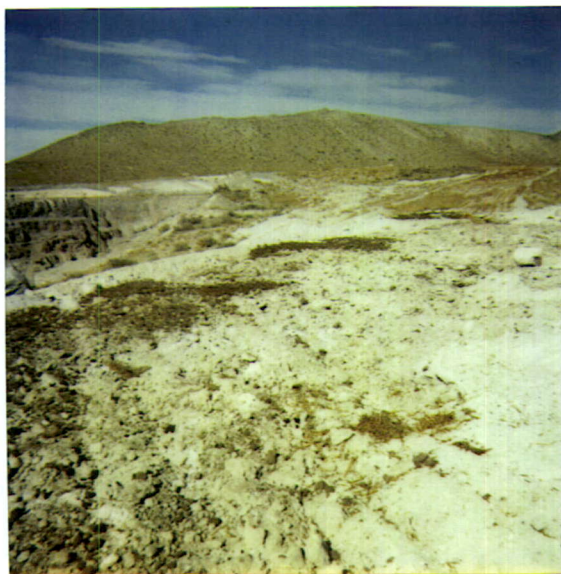
3.

- Photo 3** Picture of cross rip on east Sigma Emma road way. Ripped cross drainage for erosion prevention, looking northwesterly. This area is estimated at 0.5 acres. It was treated with topsoil, gypsum, straw, fertilizer and seed mix.

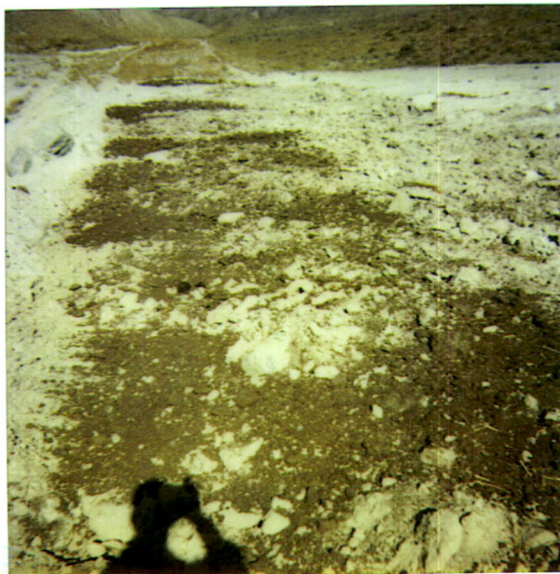
4.

- Photo 4** Picture of the reclaimed road east of the Sigma Emma pit, looking northerly. This area is estimated at 0.5 acres. It was treated with topsoil, gypsum, straw, fertilizer and seed mix.

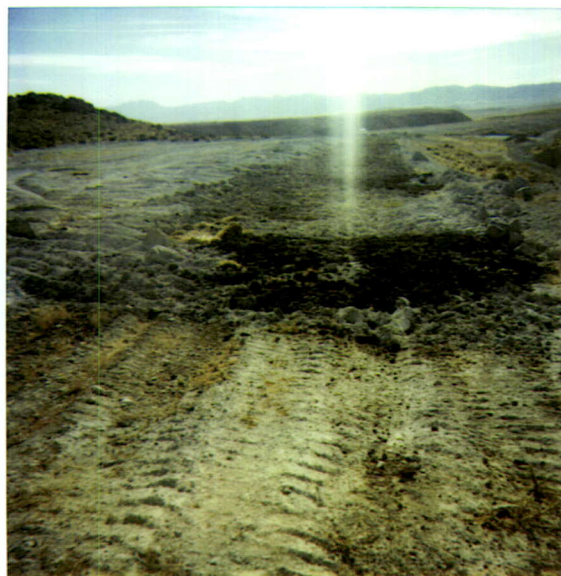
5.

- Photo 5** Picture of the reclaimed road east of the Sigma Emma pit, looking southerly. Same as picture 4.
- Photo 6** Picture of the water diverging holding pond from the east Sigma Emma road way. This pond as been bentonite lined.

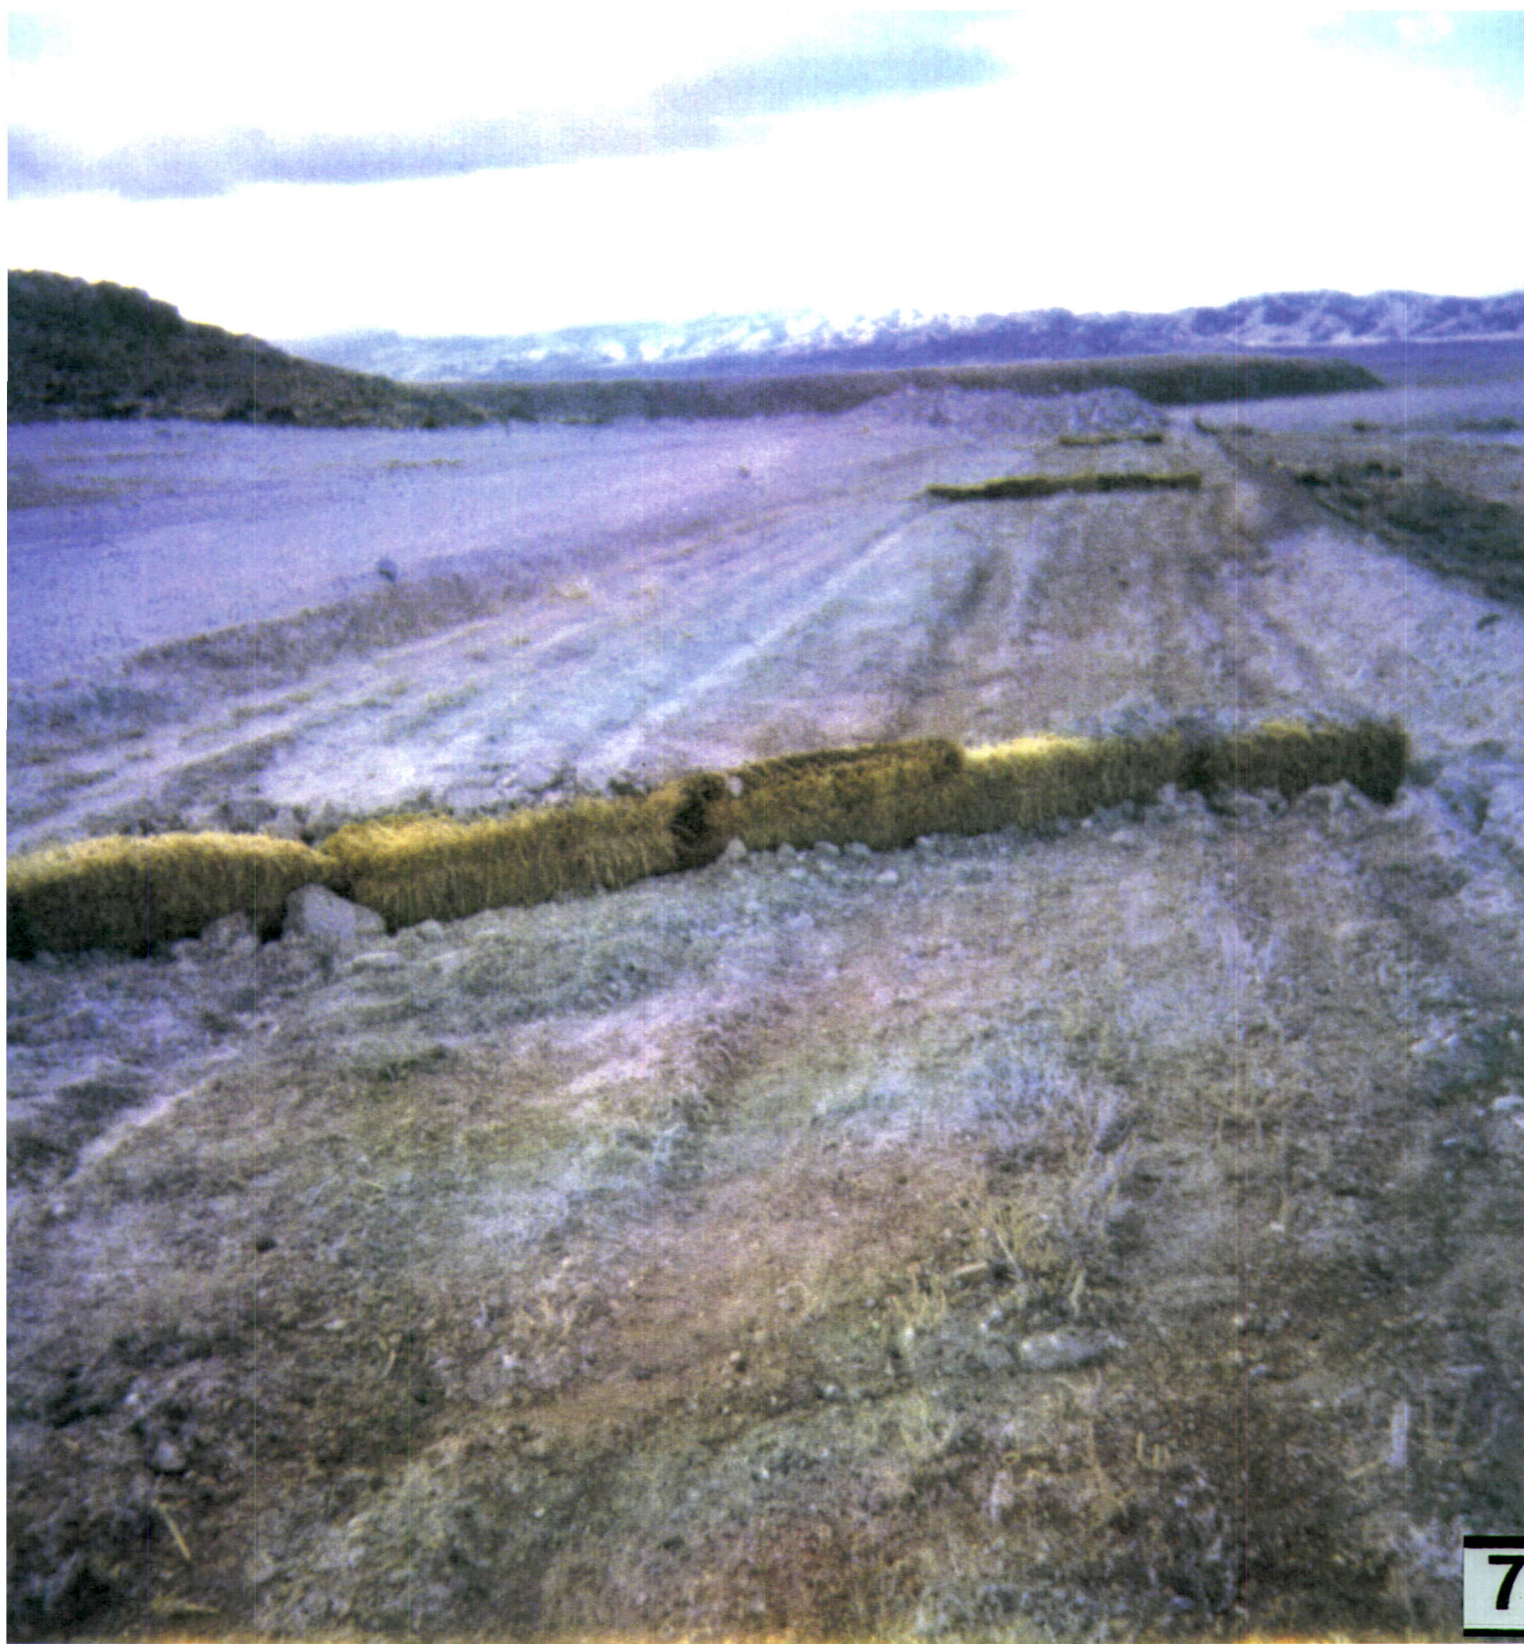
- Photo 7** Picture of reclaimed area east of Sigma Emma pit before severe erosion at waterbars improperly constructed. Reclamation work, perpendicular ripping was completed and water bars removed, looking southwesterly. This area is estimated at 0.5 acres.

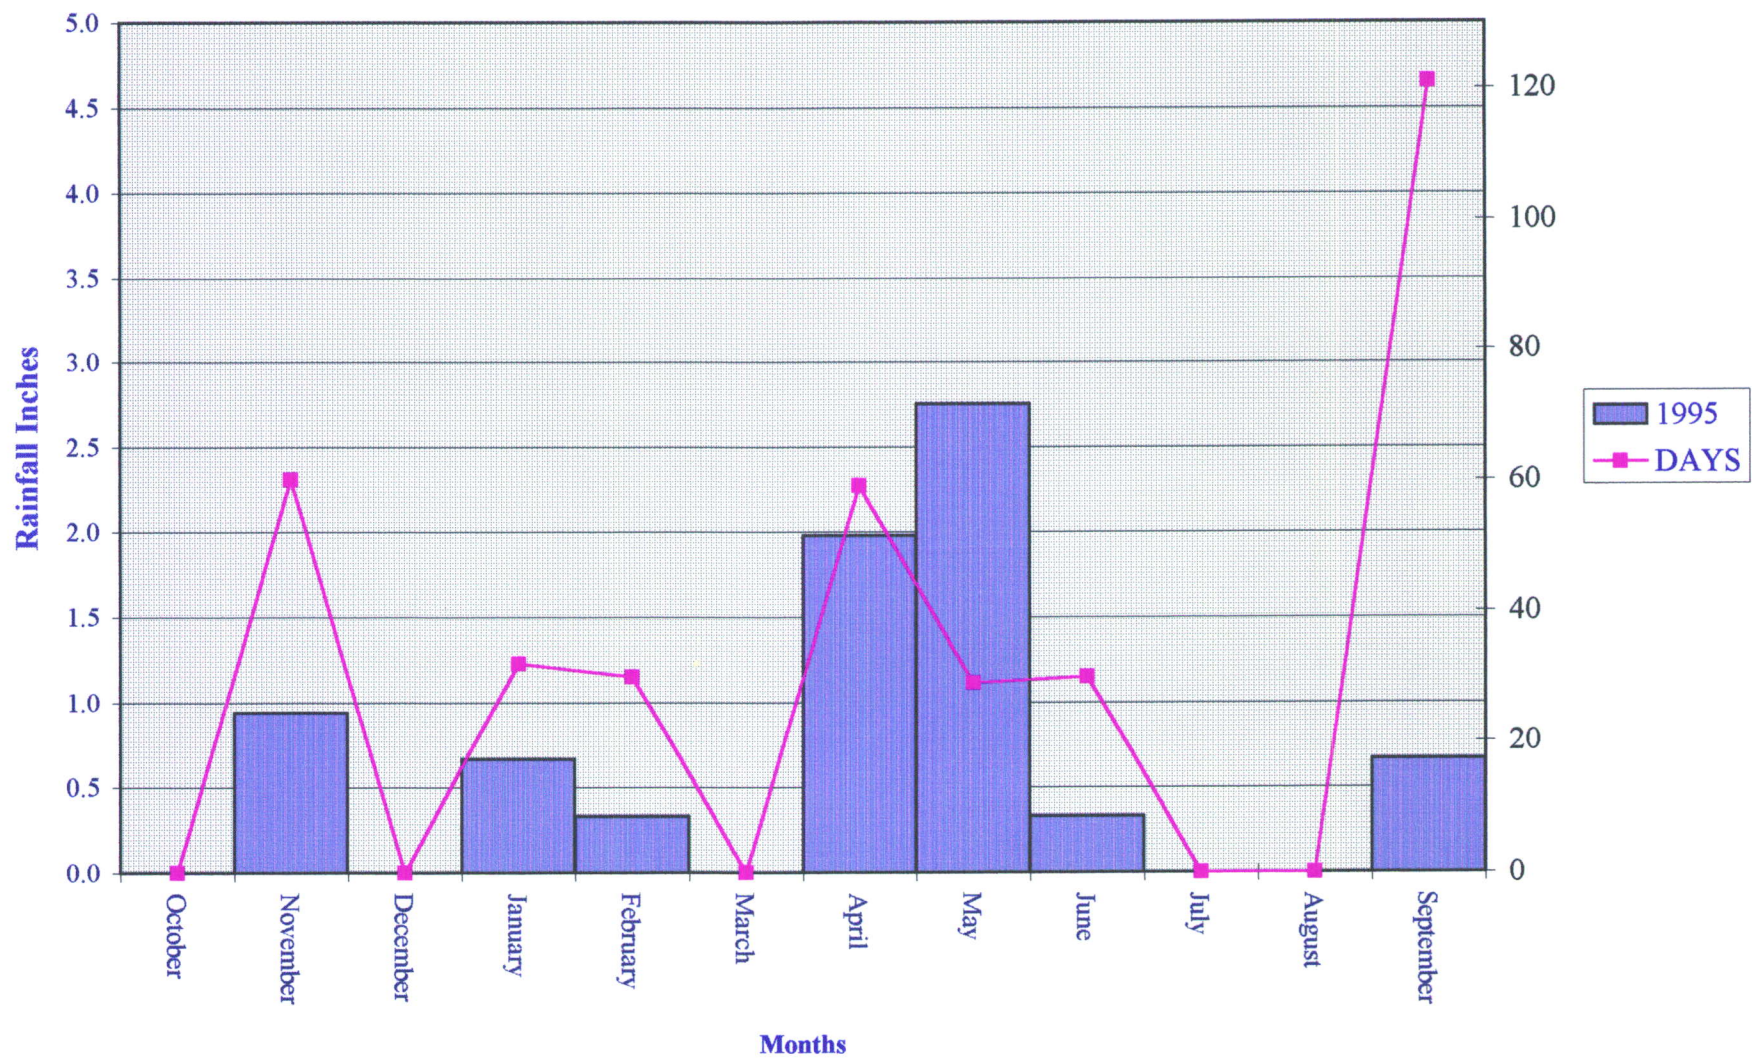
Effective Moisture Topaz Mt. 1995

Note: All measurements are in inches. The Calendar rain year begins October and ends in September.
